PROJECT ESTIMATE		CONSTRUCTION CONTROL CORPORATION				8/3/2015	
PROJECT NAME.....PARK CITY SCHOOL DISTRICT MASTER PLAN - SCHEME 1							
LOCATION.....PARK CITY, UT							
ARCHITECT.....VCBO							
STAGE OF DESIGN.....MASTER PLAN

Park City School District Master Plan – Kearns Boulevard Campus Traffic Impact Study

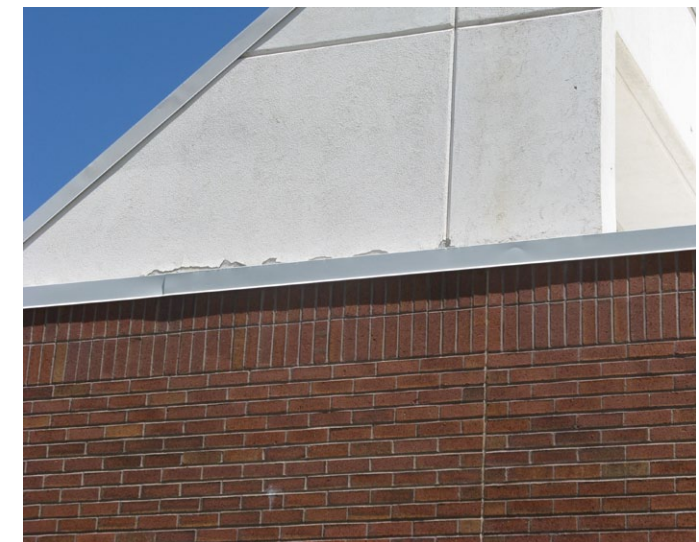
The exterior materials are in fair shape generally, however, the metal parapet shows some dents and warping. This should be maintained to prevent against the possibility of future leakage.

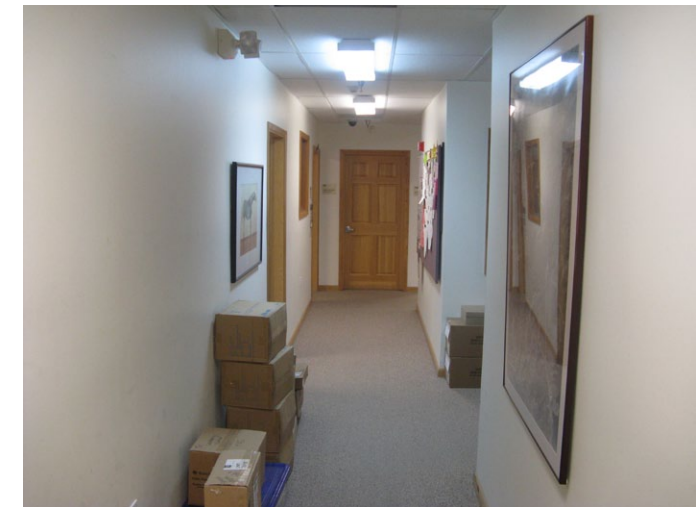
Limited storage space requires district personnel to store items in the hallways.

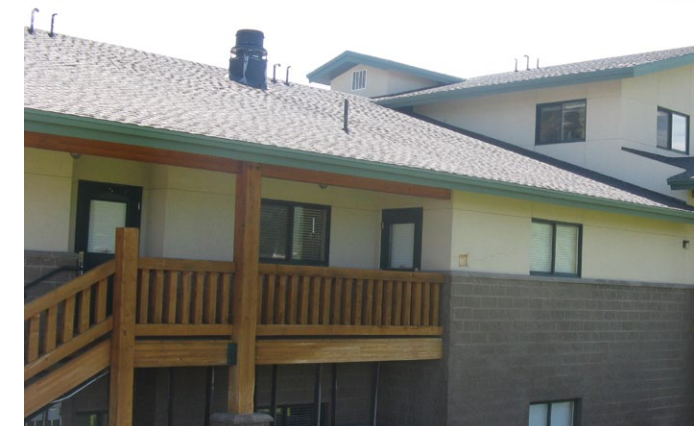
The exterior materials on the building are in poor shape. Masonry has begun breaking apart and the stucco is cracking.

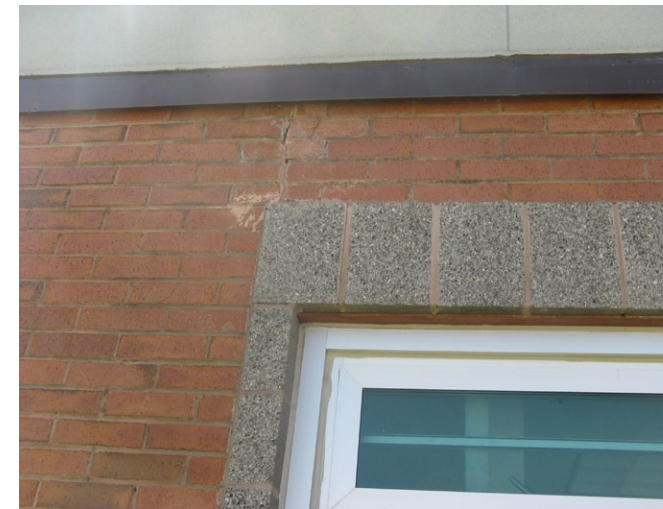
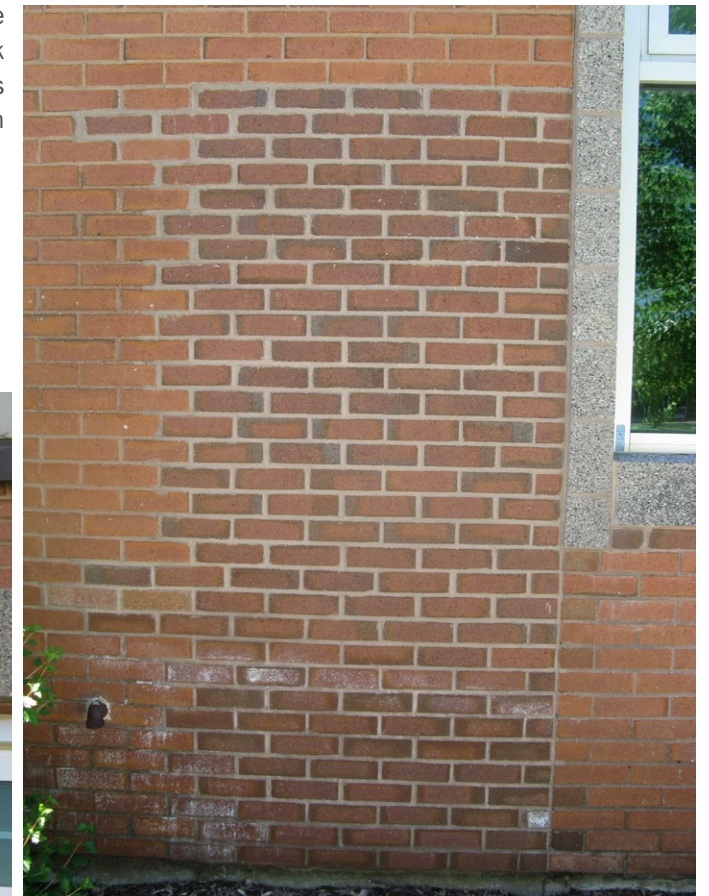
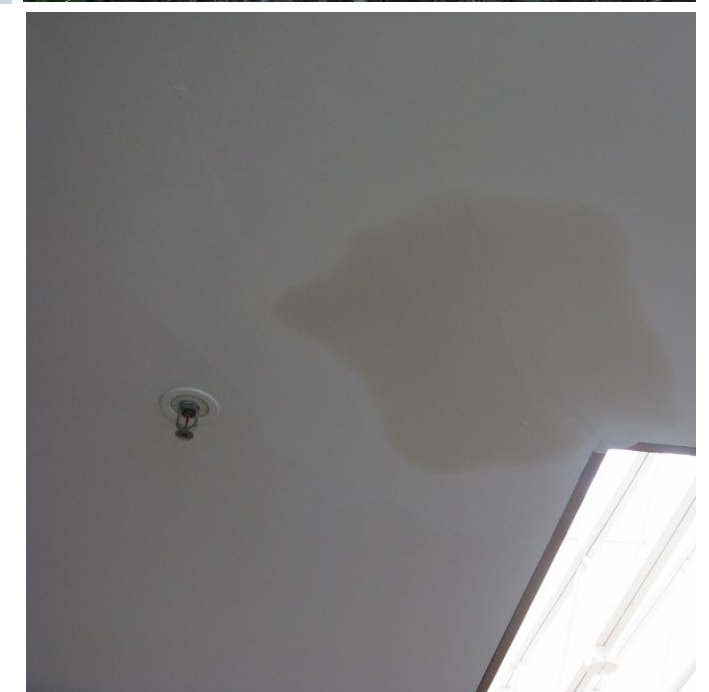
The Learning Center has some aesthetic issues at the exterior of the building. In the photo to the right the brick has been patched with a non-matching brick. The photos on the left shows an example of the cracking occurring in the masonry.
