PROJECT ESTIMATE		CONSTRUCTION CONTROL CORPORATION				8/3/2015	
PROJECT NAME.....PARK CITY SCHOOL DISTRICT MASTER PLAN - SCHEME 1							
LOCATION.....PARK CITY, UT							
ARCHITECT.....VCBO							
STAGE OF DESIGN.....MASTER PLAN

Park City School District Master Plan – Kearns Boulevard Campus Traffic Impact Study

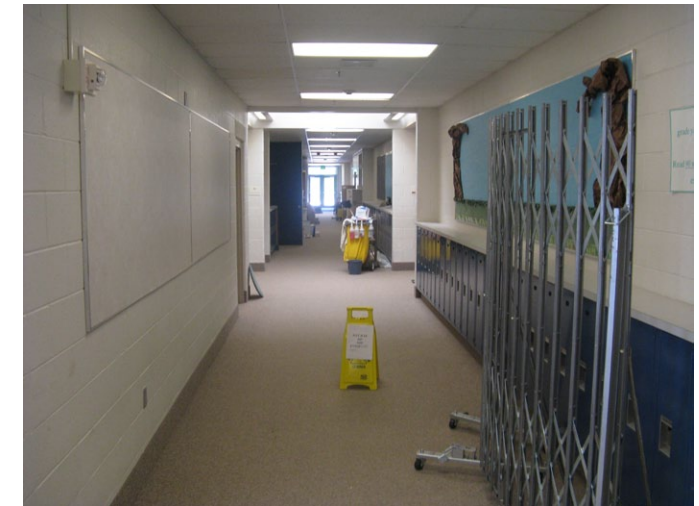
Similarly to its sister school at Jeremy Ranch, McPolin's masonry corridors minimize flexibility of the spaces.

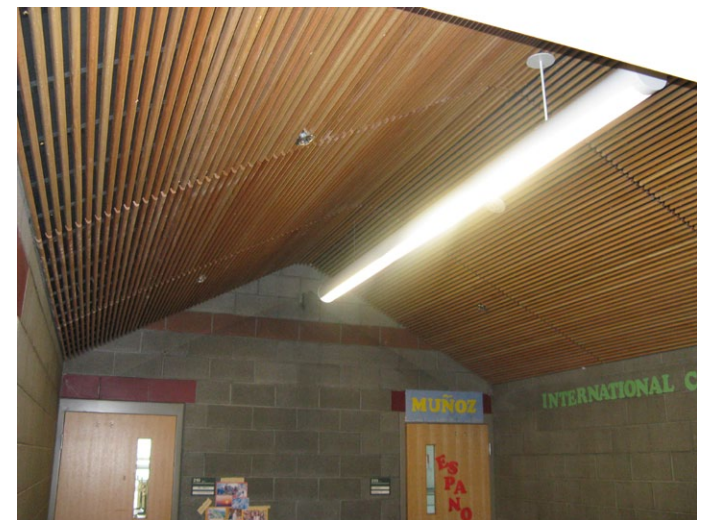
The older wing has some nice components, such as the exposed wood ceilings. However, the colors are very dark and the lighting is dated.

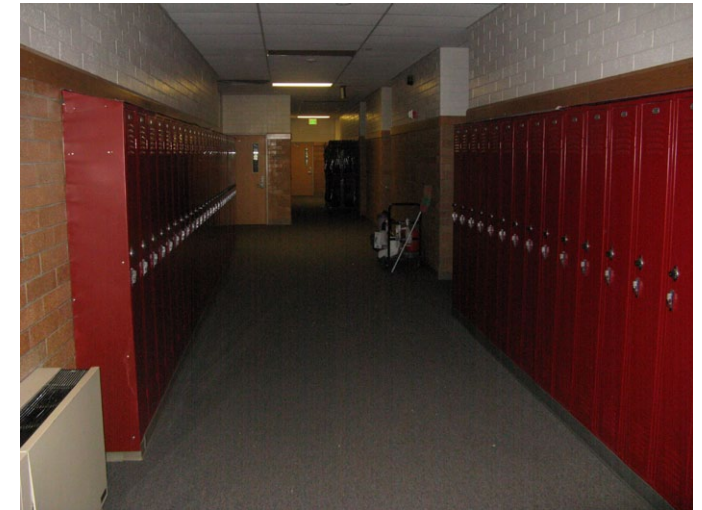
Narrow, dark corridors winding throughout the building make observation of the students and security difficult.

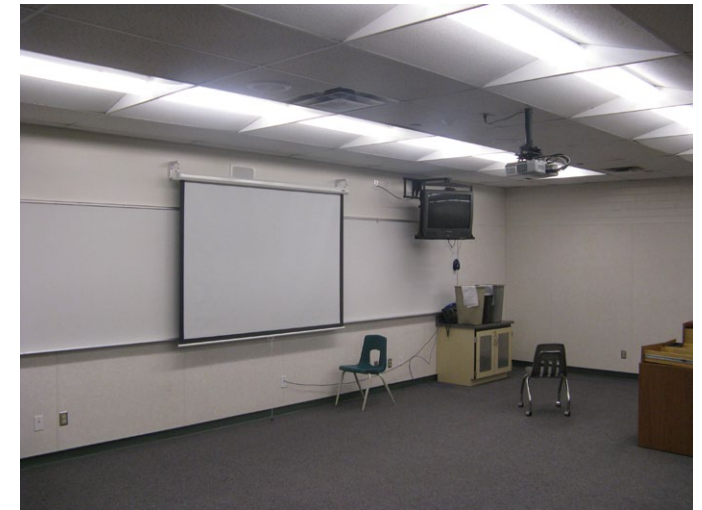
Interior classrooms without natural lighting are harmful to the student's learning experience and makes the classroom inhospitable.

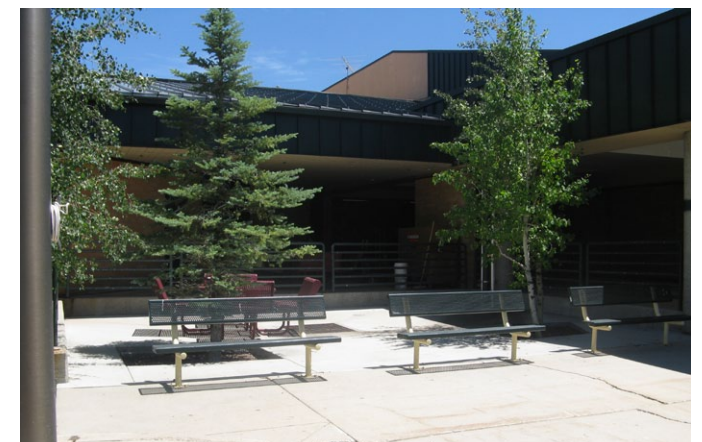
A large sloped metal roof creates large snow banks and ice at the perimeter of the building. Landscape features such as benches and trees have been added to minimize the impact.

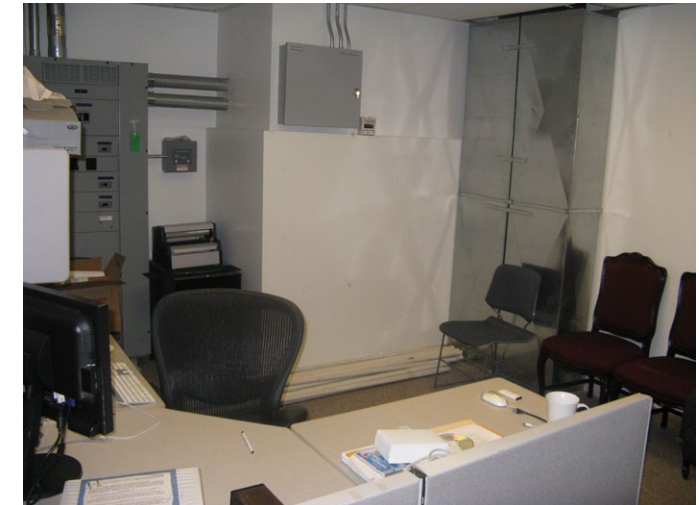
Limited storage space requires district personnel to store items in the hallways.

Spaces on the main and upper levels appear adequate for the most part. There are boxes stacked in some of the corridors, indicating that more storage space may be needed for those floors. Additional conference space is required for public board meetings as well. The IT department, currently located in the basement level of the building, has inadequate space for their people and equipment. The server room is located under a restroom currently and should be relocated. IT engineers also pointed out that the server room has inadequate air conditioning. The department needs far more work space for both their occupants and equipment. Staging and storage areas are needed as well. Given the current space issues, the IT department should be relocated, but need to remain close to Kearns Boulevard. The basement of the building is currently undergoing a small remodel.
